Davis Home Inspections

*Report of Inspection
456 Strawberry Lane
Morgantown, West Virginia*

February 14, 2003

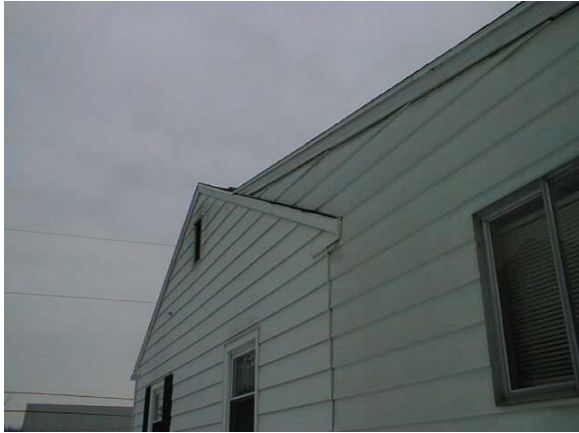
Where the addition roof attaches to the main roof, the original roof projects past the siding. This can be seen in photo 1. It is important to keep the union between the shingles and the siding sealed to prevent water entry under this wall.

Photo 1, Roof line where addition adjoins the house.

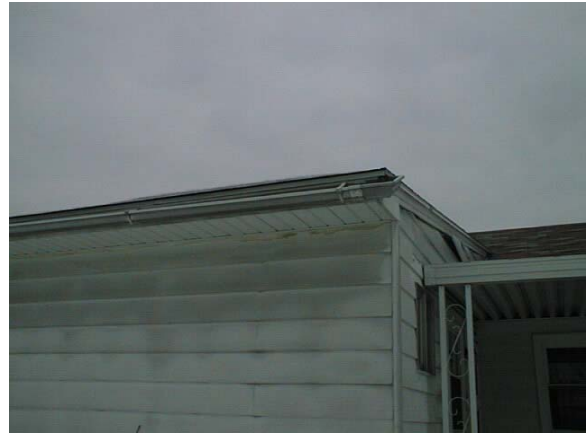
The gutters and downspouts are aluminum. The rear gutter appears to be coming off due to the weight of the ice. This can be seen in photo 2. This will have to be leveled to provide for proper slope to the downspout. The front gutter is in good condition. The downspouts are collected, that is, do not discharge onto the ground adjacent to the foundation.

The exterior of the house is covered with aluminum siding. The siding for the addition, which is over the roof of the original house, has come loose. This can also be seen in photo 2. The remainder of the siding appears to be in good condition. The soffit and fascia are aluminum and in good condition as well. The eave vents are covered with screen fabric.

Photo 2, Gutter on rear of addition coming loose. Siding loose over roof as well.

- C Re-attaching the loose siding on the rear addition.
- C Straighten the rear gutter.
- C Repair the leak in the rear awning.
- C Re-attach the loose insulation in the crawlspace.
- C Install a plastic vapor barrier in the crawlspace.

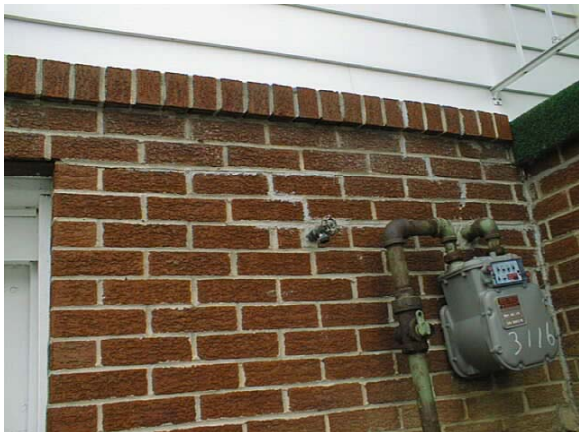
The foundation wall on the front has been covered with brick. The brick has mortar joint cracks around the garage door, behind the gas meter, and on the front porch. Behind the gas meter can be viewed in photo 3. The cap brick needs to be caulked along the siding to prevent water intrusion. Photo 4 shows that the brick has settled on the right half of the front starting at zero at the porch to approximately one (1) inch at the corner. This has exposed the wood plate behind. The plate needs to be protected from the weather and possible insect entry.

Photo 3, Mortar joint cracking in brick behind gas meter.

The brick over the garage door is supported by a steel angle. This angle is currently rusting and needs to be painted. The brick which is cracking should be re-pointed to prevent water entry behind the brick.

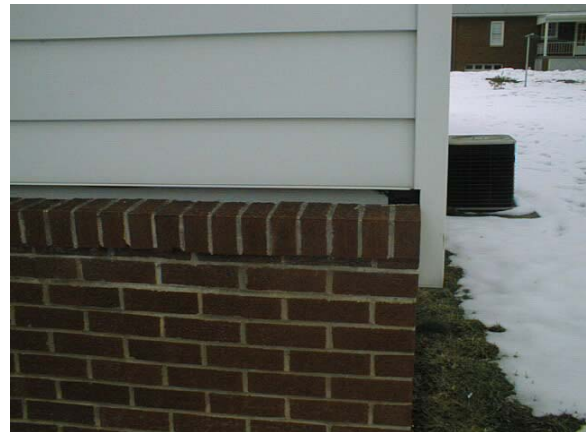
Photo 4, Brick settled between porch and corner. Note exposed wood header board.

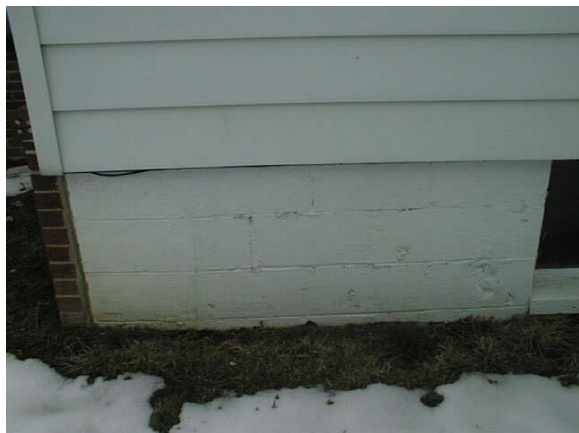
The foundation is constructed using eight (8) inch concrete block. Being an older foundation, it not uncommon for there to be mortar joint cracking as is present in this foundation. The addition is constructed on a block crawlspace foundation. The brick facade is exhibiting mortar joint cracking, however, this is not an integral part of the foundation. The majority of the foundation wall is below ground level. The most noticeable mortar joint crack on the exterior is located on the right between the front corner and the window. This can be seen in photo 5. Visible cracking was minimal.

Photo 5, Mortar joint crack in foundation, right side between corner and window.

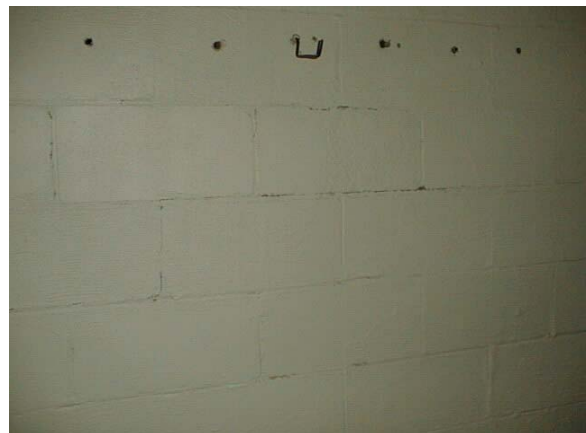
Interior examination of the foundation found similar conditions. On the front wall, there is an area of stair-step mortar joint cracking five blocks from the corner. This can be seen in photo 6. There is a vertical hairline mortar joint crack approximately two blocks from the corner. This can be seen in photo 7. Additionally, there is a mortar joint crack adjacent to the garage door opening. This wall is plumb and does not have any bowing or bulging present. The cracks do not appear to be structurally significant.

Photo 6, Stair-step mortar joint crack on front wall in basement.

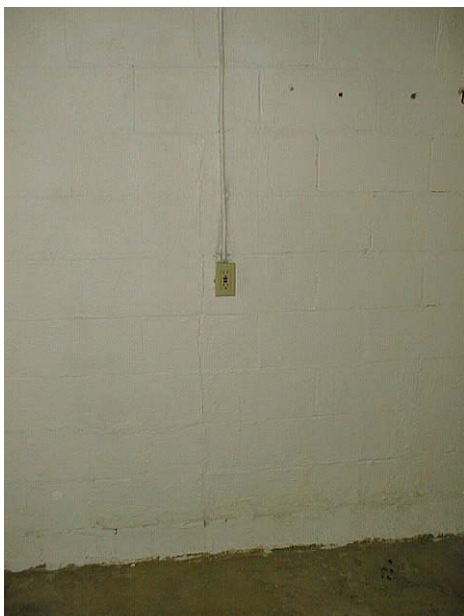
Photo 7, Vertical hairline mortar joint crack adjacent to receptacle on front wall, near corner.

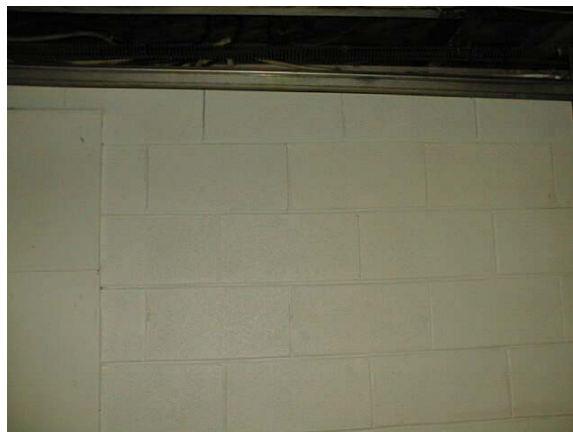
The left foundation wall has a mortar joint crack to the right of the electric panel. This can be seen in photo 8. This crack does not appear to be structurally significant. There are indications of previous water entry along this wall. Efflorescence is present under the paint on the bottom four courses of block. There are indications that a perimeter drain has been installed along the wall. The floor cut and patch can be seen in photo 9. There were no indications of active water entry along this wall.

Photo 8, Mortar joint crack to the right of the electric panel, left wall.

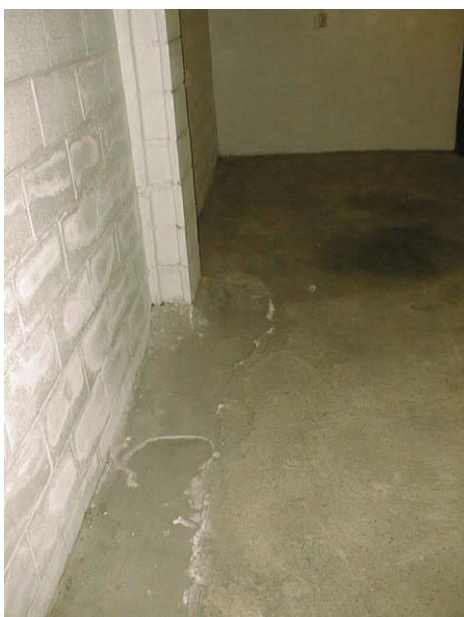
Photo 9, Example of where concrete was removed and drain was installed.

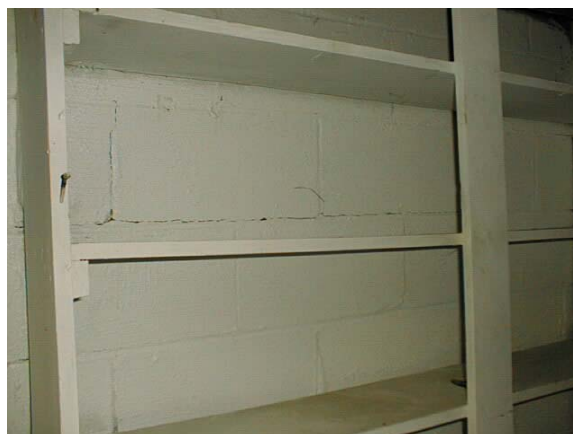
The rear wall has two pilasters constructed to provide additional support. Between the pilasters, behind the shelving, there is a horizontal mortar joint crack occurring three block courses from the top. This can be seen in photo 10. The wall in this area is exhibiting a bow in the middle which is ½ inch out of plumb. The crack should be caulked. The pilasters should provide adequate reinforcement to this wall. Additionally, the concrete patio should reduce the water entering the soil reducing the possibility of soil expansion.

Photo 9, Horizontal mortar joint crack on rear wall between pilasters.

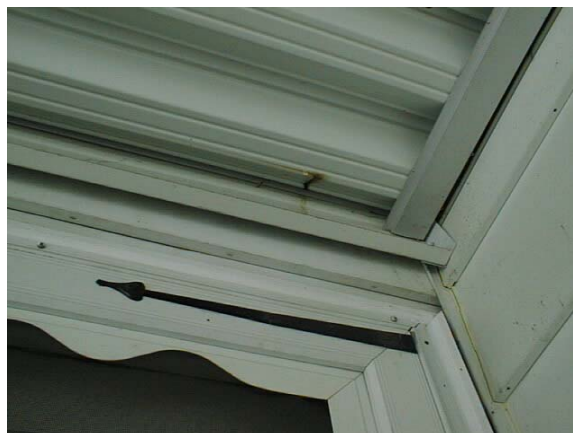
On the rear of the house, there is a concrete patio. The concrete has an expansion crack extending from the stairs to the edge of the slab. This is a common occurrence. The concrete is level. To help keep surface water from getting under the patio, it is recommended to caulk along the slab and wall. The patio is covered by an aluminum awning. A leak is present directly above the rear door. This can be seen in photo 11.

Photo 11, Leak in rear awning above door.

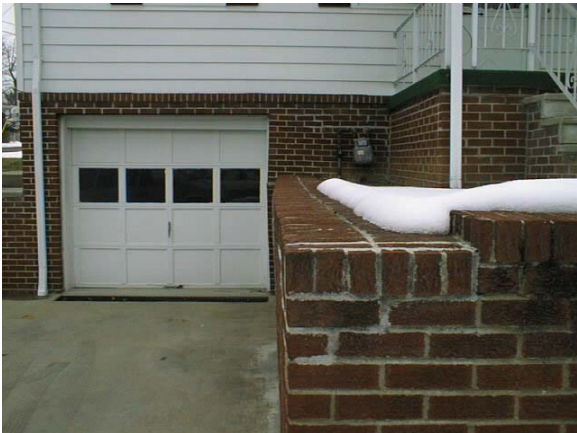
Along the driveway and the front of the property there are retaining walls. The right retaining wall along the driveway is bowing in the middle. This can be seen in photo 12. This does not appear, however, to be a major concern at this time.

Photo 12, Bow in driveway retaining wall.

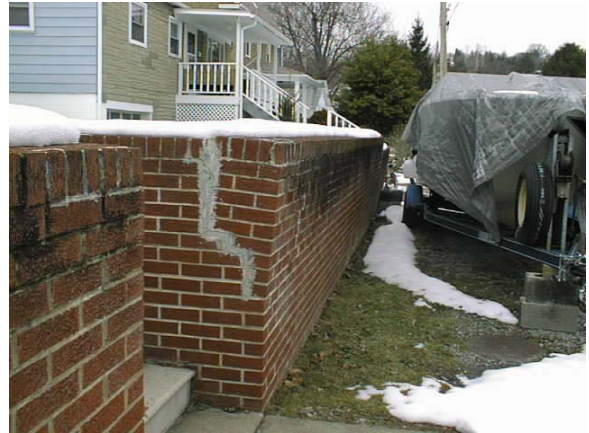
The front retaining wall is jointly owned with the neighboring property. This property owns the wall to approximately seven (7) feet from the right side of the house. The wall is bowing, mainly the top three (3) courses of block. This can be seen in photo 13.

The wall belonging to this property is not bowing as much as the neighbors portion, only approximately two (2) inches out of plumb. The neighbor’s portion of the wall is

Photo 13, Front retaining wall, leaning approximately two inches out of plumb.

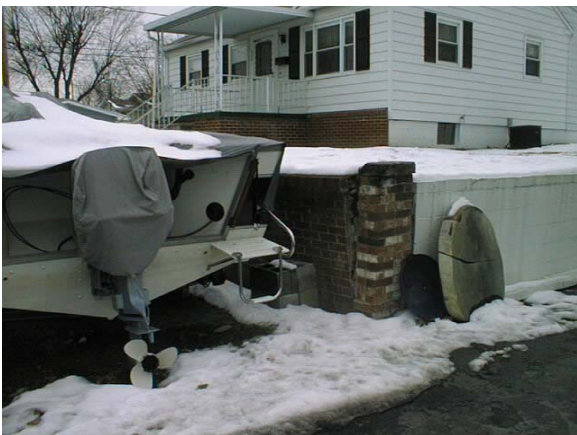
breaking loose at the corner with their driveway wall, being more than six (6) inches out of plumb. This can be seen in photo 14. It appears that the movement on the neighboring portion of the wall is contributing to the movement on this property's portion. This is being caused by expansive soils and water collecting behind the wall. There are no weep holes present to release the water. Eventually, this wall will need to be repaired and weep holes should be installed at that time.

Photo 14, Neighbors end of retaining wall.

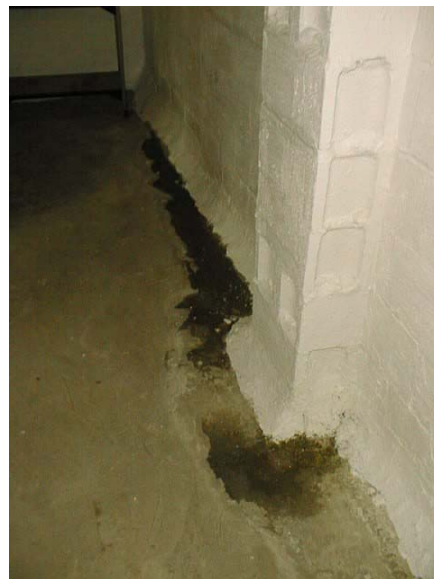
The basement is unfinished. The foundation walls are discussed in the foundation section above. As mentioned above, the right wall has what appears to be a drain around the perimeter under the floor. Since the inspection, the snow has melted and there has been precipitation. On the date of this report, Saturday February 12, I returned to the house to check the basement. Water was present along the right wall, as can be seen in photo 15. It appears that the water is seeping through the wall and exiting where the B-bond ends. This can be seen in photo 16. This was the only location where water was entering the basement at this time.

Photo 15, Water along right foundation wall, taken 2-12-00.

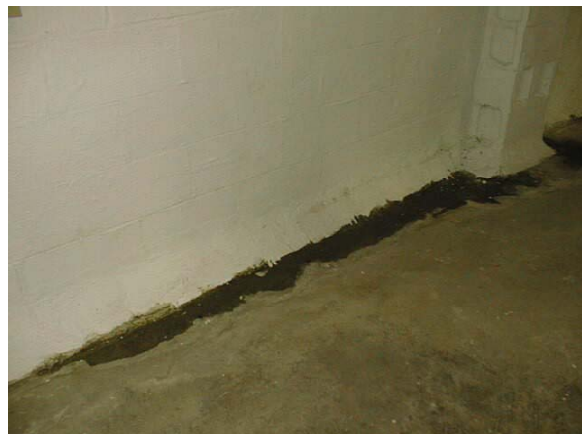
Photo 16, Showing water exiting the wall at the bottom of the B-bond.

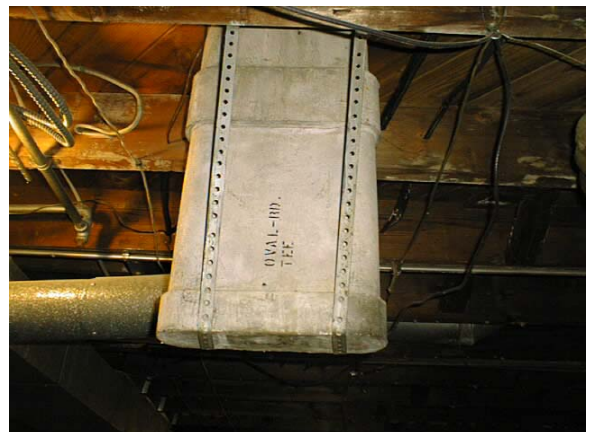
The vent pipe for the furnace and hot water heater is made from asbestos cement. It does not appear to be breaking down, however, in the exposed areas, the pipe should be painted to encapsulate the asbestos. This includes the basement and main hall closet.

Photo 17, Asbestos cement vent pipe in basement.

- C Encapsulating the asbestos vent pipe by painting.
- C Consider installing additional smoke detectors in the bedrooms.
